**DEVELOPMENT OF FRACTURE MECHANICS DATA FOR  
TWO HYDRAZINE APU TURBINE WHEEL MATERIALS**

George Curbishley  
AiResearch Manufacturing Company of California  
2525 W. 190th St.  
Torrance, Calif. 90509

February 1975

Final Report for Period July 1973 - December 1974

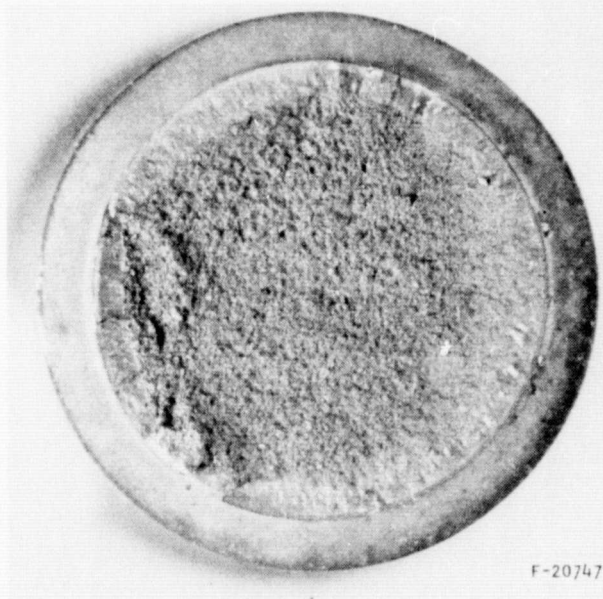
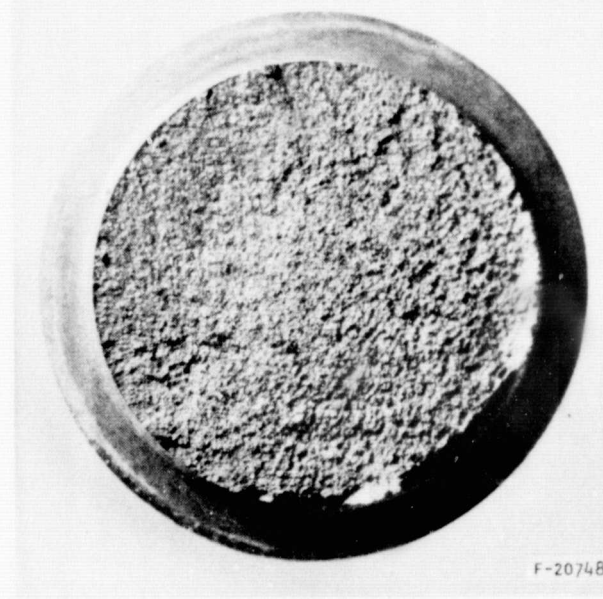
Figure 26. Typical Fatigue Fracture Surfaces  
Rene' 41 Specimens

HCF and LCF Fatigue test results are tabulated in Tables XI through IV (SI Units) and XV through XVIII (U.S. Customary Units). A histogram (figure 25) also shows the relative fatigue life of the various combinations of materials, coatings and atmospheres. The fractured surfaces of the fatigue specimens are depicted in figures 26 and 27.

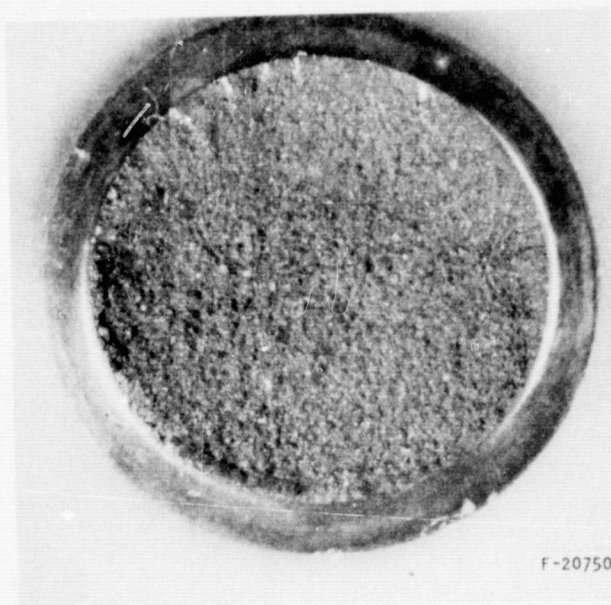
Figure 27. Typical Fatigue Fracture Surfaces  
Astroloy Specimens

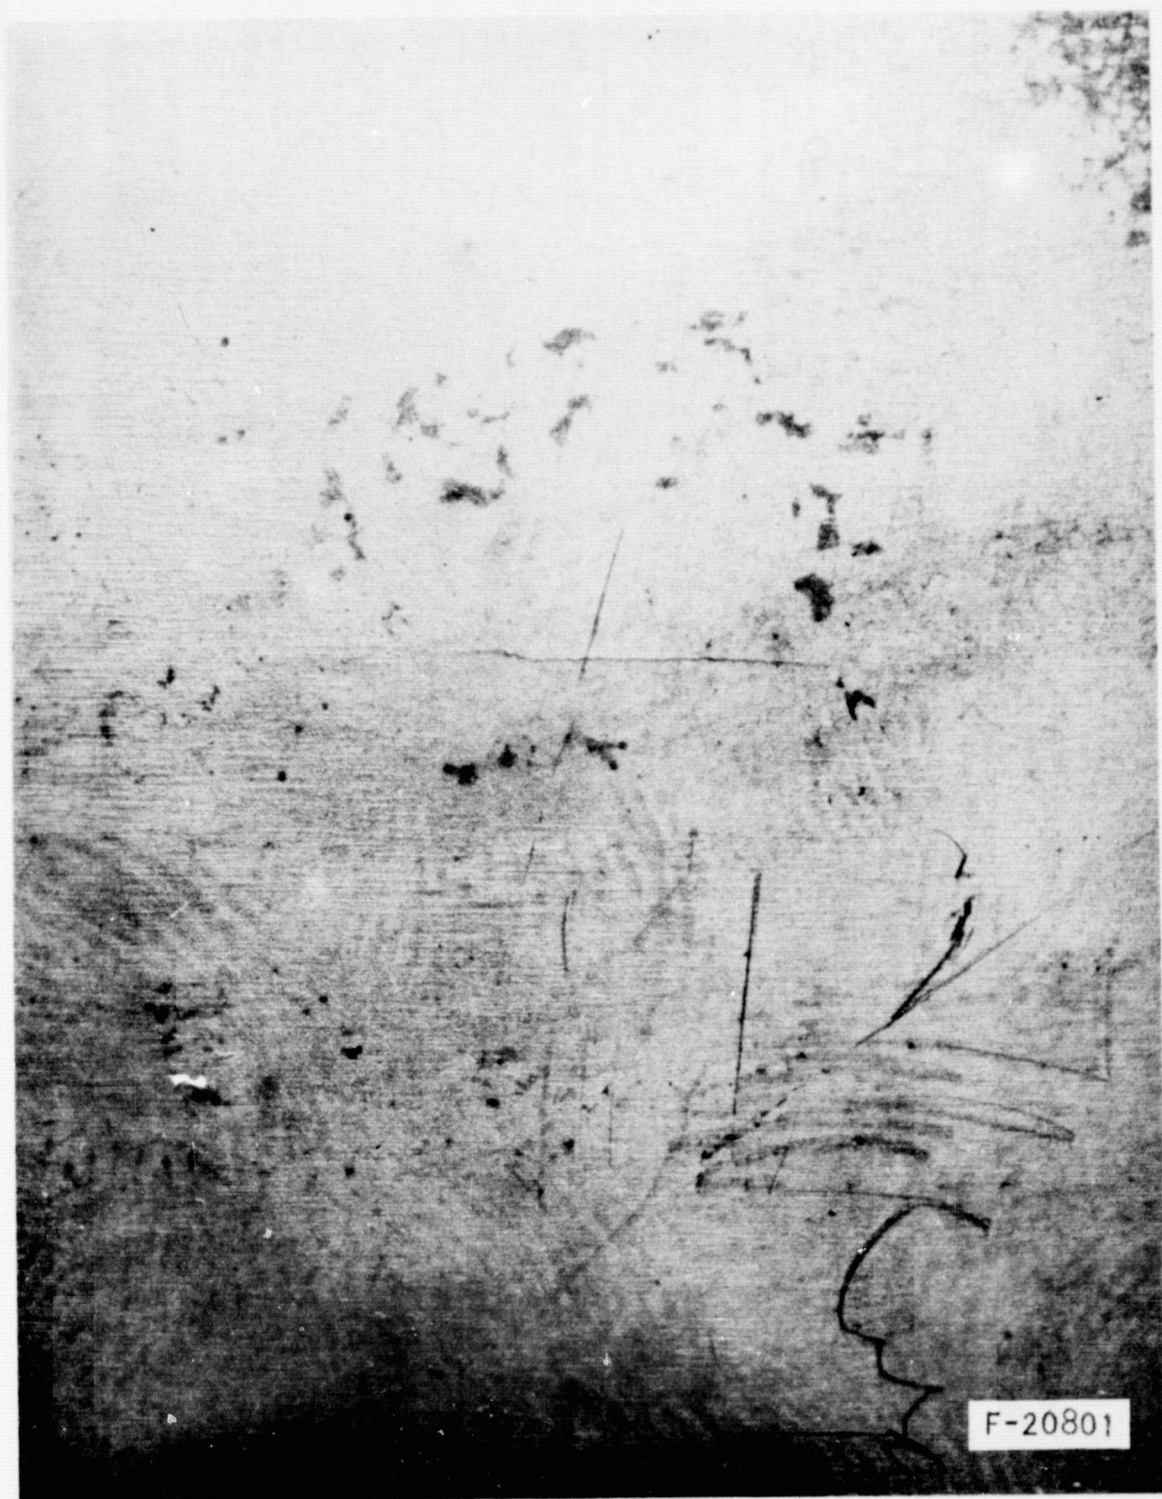
Figure 29. Specimen R32, Gold Plated, Tested in Ammonia. The gold plating over the fissure had cracked, but no appreciable crack hardening was detected. Subsequent rupturing revealed that no crack growth had taken place.

Crack growth during testing was usually accompanied by crack widening. Figure 28 shows the typical appearance of a gold plated specimen before testing. A specimen which exhibited no growth, and a specimen which did experience some crack growth but did not rupture are illustrated in figures 29 and 30. Note that prior to testing the original fatigue crack is covered by the gold and is all but invisible. In the second case the strain has been sufficient to rupture the gold plating, but no appreciable crack widening was observed. In the third case crack widening is obvious.
